# Home Inspection Report

19 New Home Ave Staten Island, New York 10303

Report Number 66-011524PD1

Inspection Date 2024-01-15

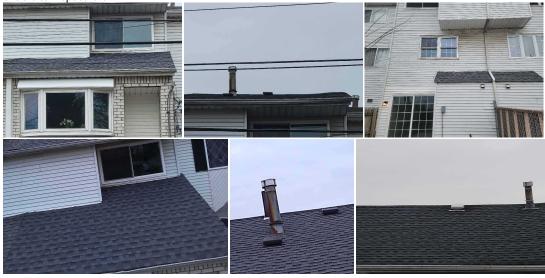
#### Main Roof Surface -

2. Inspected Unable to Inspect: 0%

3. Inspected Material: 3 Tab, Asphalt shingle

5. Approximate Age: 0 Yrs. - 5 Yrs.
