# Home Inspection Report

18 Anywhere Ln  
Staten Island, NY 10314

# P & D Home Inspections

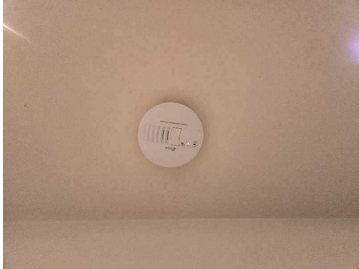
27. Recommendation Smoke/Carbon Monoxide Detector Appears to be battery operated - [Recommend that Smoke/ Carbon monoxide Detectors be installed in all bedrooms, hallways, first floor near kitchen, and at basement stairs. Carbon Monoxide detectors should be a plug in type that will register low level readings.](#)

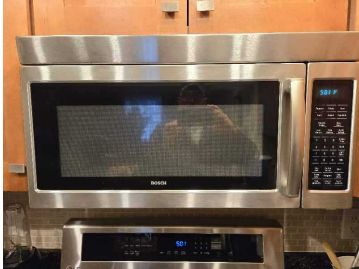
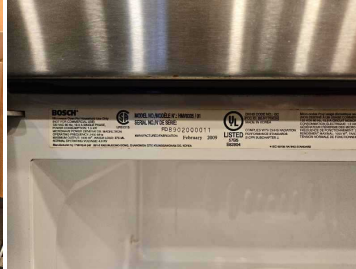
Ventilator: Bosch - **The range hood/built-in microwave self vents back into kitchen**

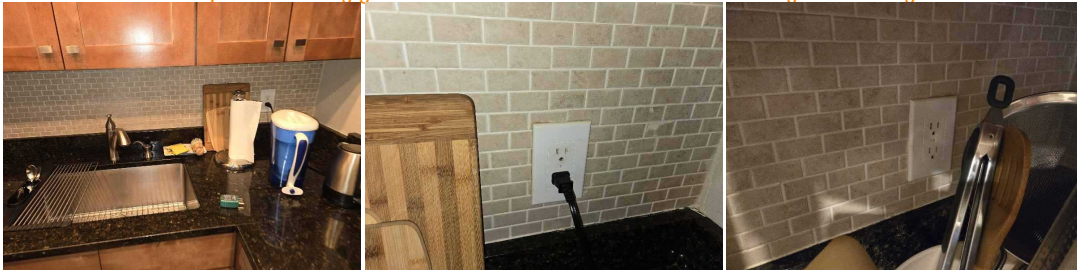
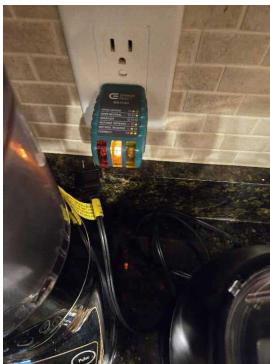
Electrical: 110 VAC lighting, 110 VAC GFCI - The 2 outlets that are with-in 6 feet of the sink are Non-GFCI circuit -recommend GFCI circuit be installed, Open or missing ground was detected on outlet between Range and Refrigerator.

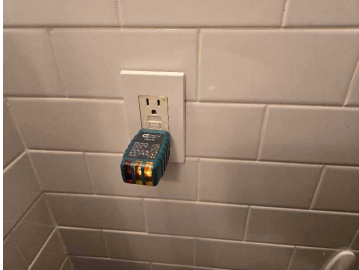
Electrical: 110 VAC lighting, 110 VAC GFCI - The outlet is loose and appears to be pulling free from its mounting to be outlet box. Recommend contacting a licensed Electrical contractor for evaluation and repair.

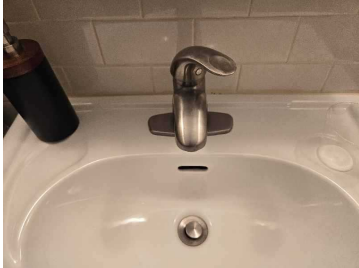
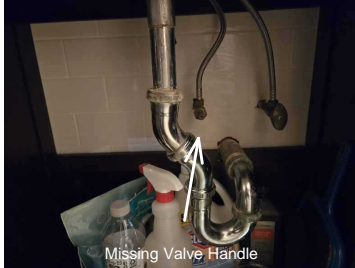
10. Maintenance Item Plumbing/Fixtures: Single lever, Stainless steel. The shutoff valves are silver rotary style with metal braided flex lines. Metal drain lines. **The hot water shutoff valve is missing its handle. Installation of new handle is recommended.**

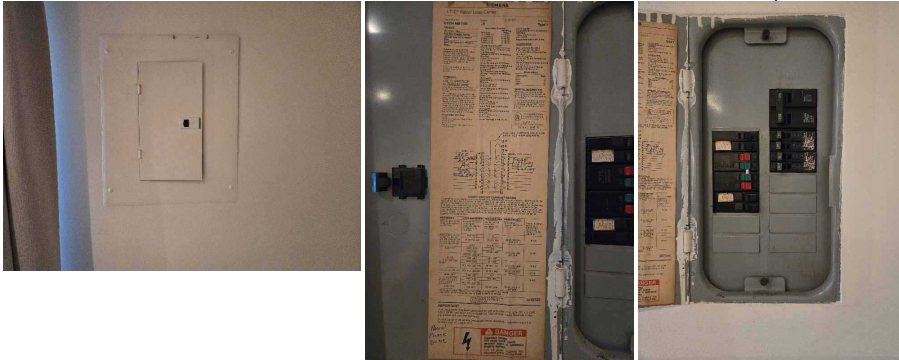
1. Recommendation Manufacturer: SIEMENS - Due to the electrical panel cover front being painted to the wall and the cover front screws being painted over, so as not to cause damage to the surrounding paint the inspector was unable to remove cover front to inspect inside. It's recommended that a licensed Electrician be contacted for an evaluation of the panel after closing.

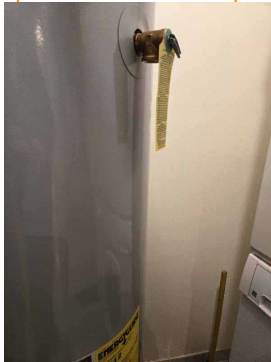
14. Maintenance Item TPRV and Drain Tube: Missing - TPR Valve drain tube is missing. Recommend drain tube be installed and should not be more that 6 inches from the floor. This is to help prevent scalding, by hot water, of anyone that may be nearby should the pressure relief valve open to release excess pressure/water buildup in the hot water heater.

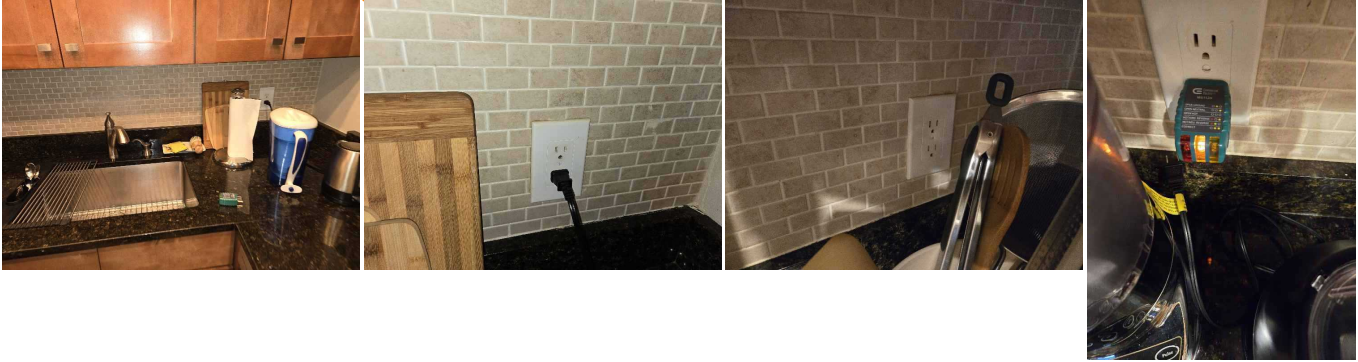
1. 1st Floor Kitchen Electrical: 110 VAC lighting, 110 VAC GFCI - The 2 outlets that are with-in 6 feet of the sink are Non-GFCI circuit -recommend GFCI circuit be installed, Open or missing ground was detected on outlet between Range and Refrigerator.

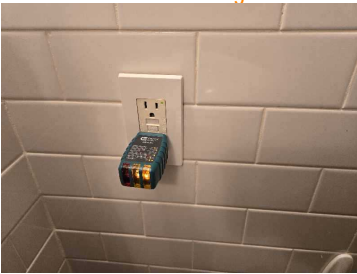
2. 1st floor main Bathroom Electrical: 110 VAC lighting, 110 VAC GFCI - The outlet is loose and appears to be pulling free from its mounting to be outlet box. Recommend contacting a licensed Electrical contractor for evaluation and repair.

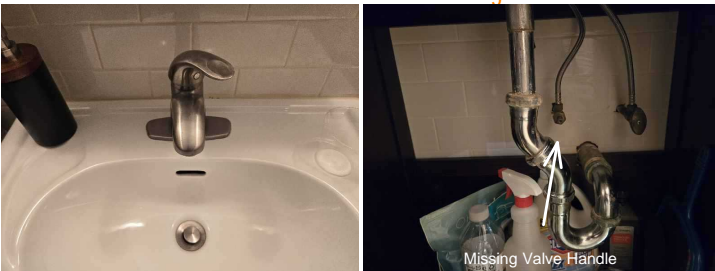
3. 1st floor main Bathroom Plumbing/Fixtures: Single lever, Stainless steel. The shutoff valves are silver rotary style with metal braided flex lines. Metal drain lines. The hot water shutoff valve is missing its handle. Installation of new handle is recommended.

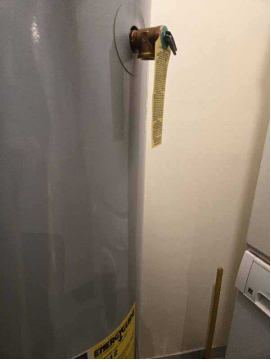
4. Laundry room Water Heater TPRV and Drain Tube: Missing - TPR Valve drain tube is missing. Recommend drain tube be installed and should not be more that 6 inches from the floor. This is to help prevent scalding, by hot water, of anyone that may be nearby should the pressure relief valve open to release excess pressure/water buildup in the hot water heater.

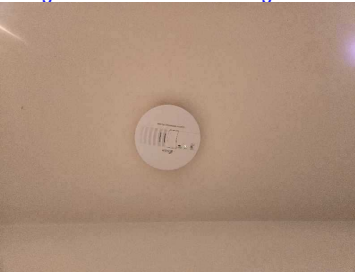
1. Hallway Living Space Smoke/Carbon Monoxide Detector Appears to be battery operated - Recommend that Smoke/ Carbon monoxide Detectors be installed in all bedrooms, hallways, first floor near kitchen, and at basement stairs. Carbon Monoxide detectors should be a plug in type that will register low level readings.

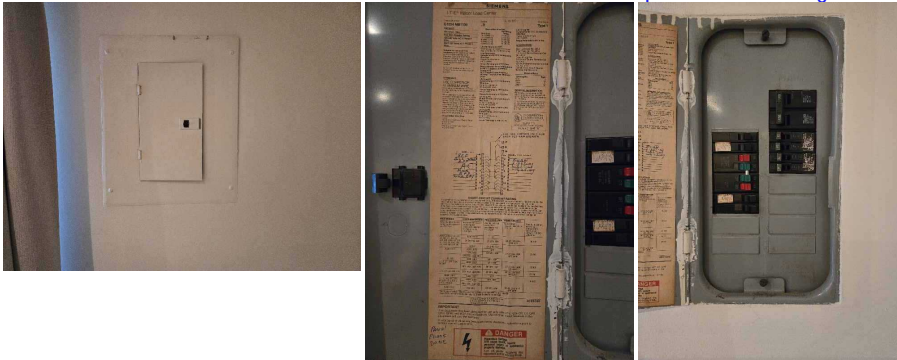
2. Foyer Electric Panel Manufacturer: SIEMENS - Due to the electrical panel cover front being painted to the wall and the cover front screws being painted over, so as not to cause damage to the surrounding paint the inspector was unable to remove cover front to inspect inside. It's recommended that a licensed Electrician be contacted for an evaluation of the panel after closing.
