Home Inspection Report

1234 Home St.
Staten Island, NY 10310

P & D Home Inspections

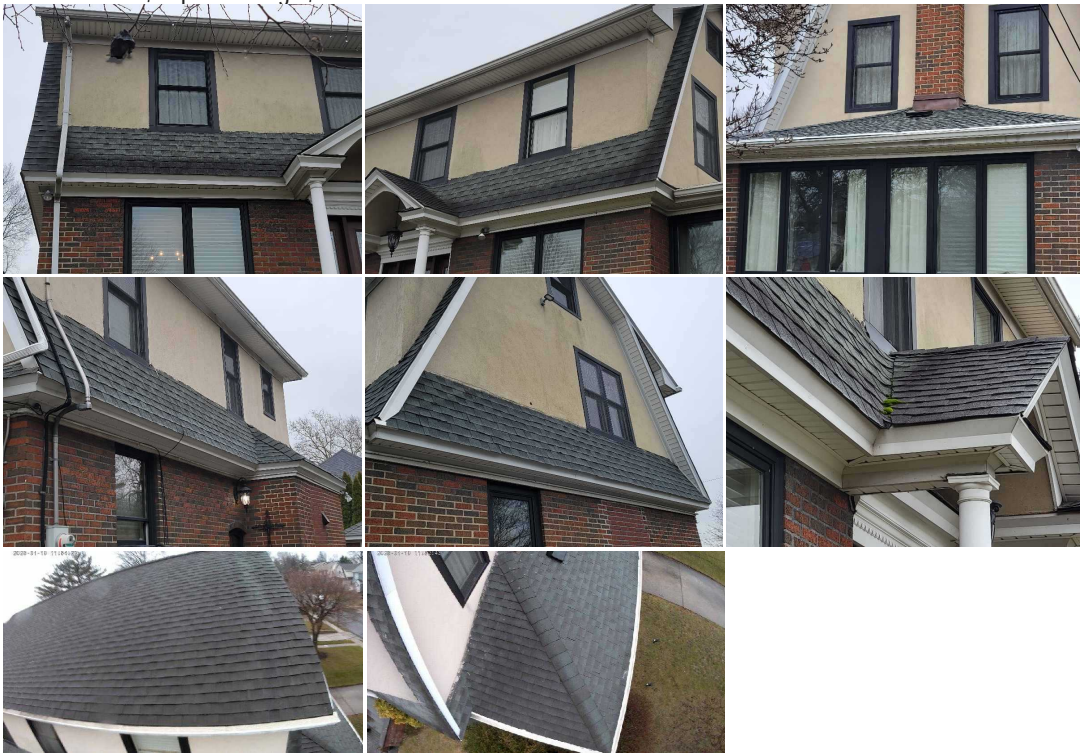
3. Functional Material: 3 Tab, Asphalt shingle, Dimensional

4. Type: Shed, Hip

5. Approximate Age: Greater than 10 Yrs

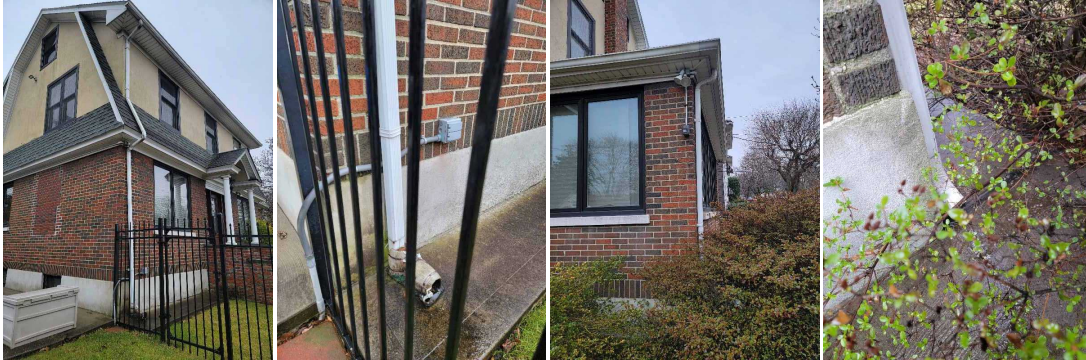
Downspouts: Aluminum

12. Maintenance Item Leader/Extension: None - No Leaders/extensions were observed during the inspection, Extend runoff drains to move water away from foundation

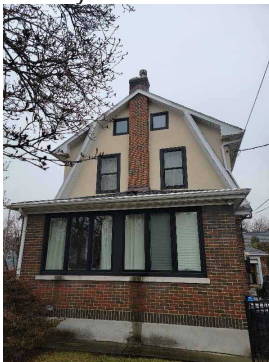
14. Maintenance Item Flue/Flue Cap: Metal, Concrete - A portion of the metal Chimney cap appears to have raised up on one side. This may cause water to enter the chimney through this area and can cause damage to the chimney. It's recommended that a licensed contractor be contacted to reattach the metal cap.

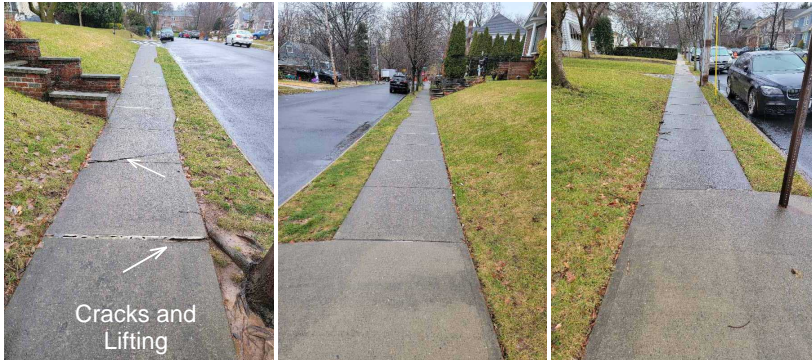
1. Maintenance Item Sidewalks: Concrete - Cracks and minor lifting was noted in the sidewalk in front of the location. It appears to be caused by the tree root shown in photo. It's recommended that the tree root be cut back, to prevent further lifting and cracking of the slabs and that the current cracks be sealed.

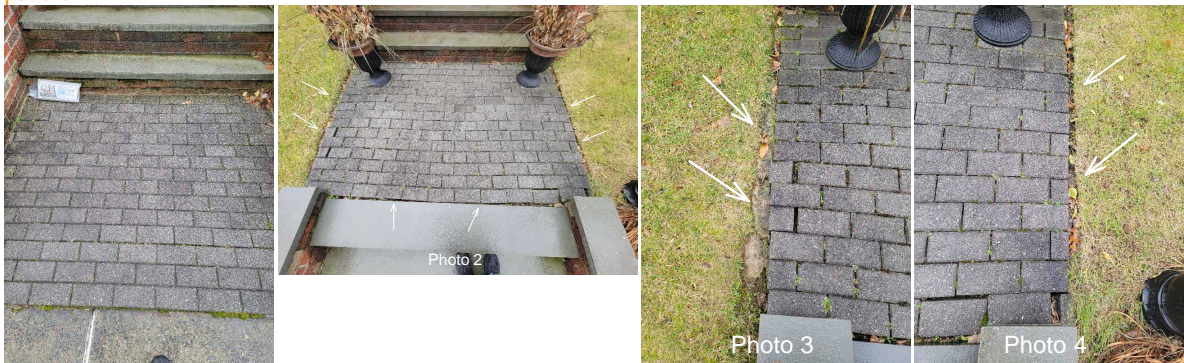
2. Maintenance Item Front Walkway: Concrete, Brick - The brick pavers on middle landing of the front steps have become slightly uneven (photo 2). The edge pavers on both sides (photo's 3&4), are pulling away due to the sinking of the concrete edging used to lock them in place. It's recommended that these pavers be reset and new edging, either concrete or pvc, be installed to prevent further movement of the pavers.

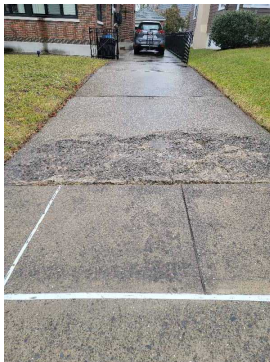
4. Maintenance Item Driveway: Concrete - The front portion of the driveway is chipped and pitted. It's recommended that a licensed Masonry contractor be contacted for evaluation and possible repair.

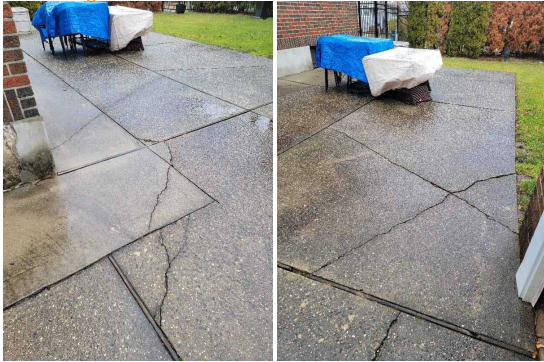
8. Maintenance Item Patio: Concrete - The rear patio has numerous cracks in the slabs, but was still even. To prevent further cracking and the slabs becoming uneven it's recommended that the cracks be sealed. Evaluation by a licensed Masonry contractor is recommended.

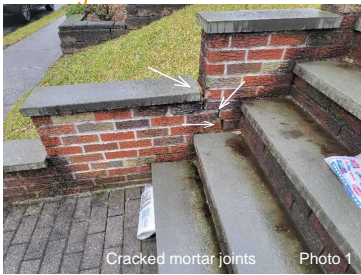
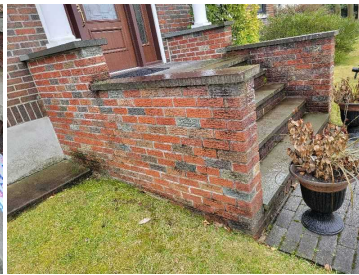
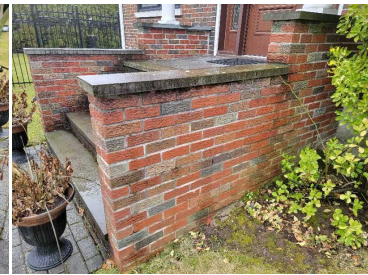
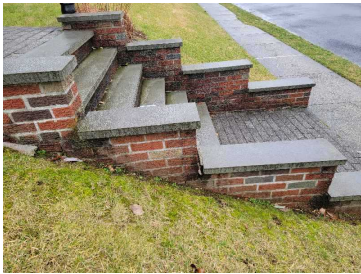
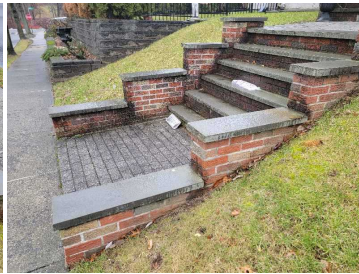
Retaining Walls: Brick - A minor downward sloping of the lower left side wall of the front steps has caused a few mortar joints to crack in what's called a step crack pattern. See photo 1. Repointing of the area is recommended to prevent any possible, further cracking.

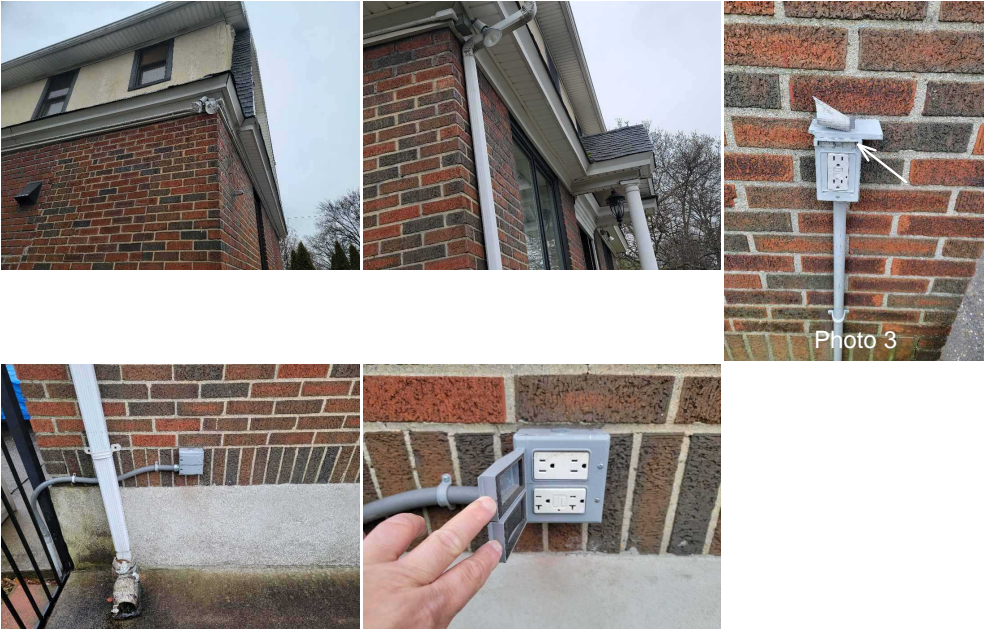
19. Maintenance Item Exterior Electric Outlets: GFCI with weather resistant cover - The GFCI located at the exterior, side, garage wall has a broken weather resistant cover. It's recommended a new cover be installed. Photo 3.

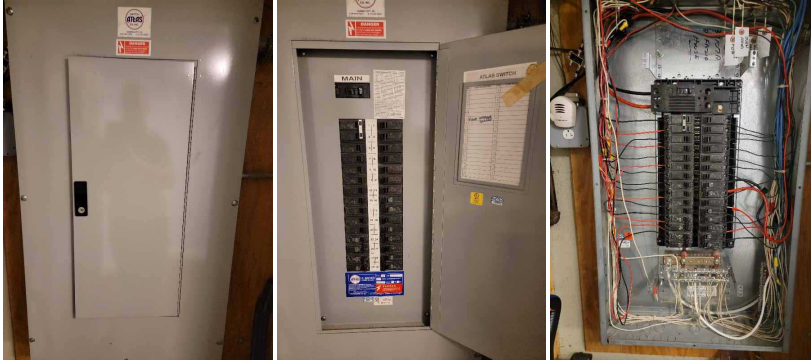
1. Functional Manufacturer: Atlas - The main electrical panel is missing a ledger which denotes which breaker serves which areas of the home. Installation of ledger is recommended.

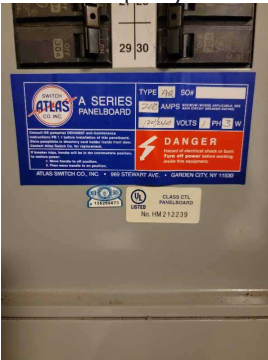
2. Volts: 120-240

3. Maximum Capacity: 200 Amps

4. Functional Main Breaker Size: 200 Amps
5. Functional Breakers: Copper
6. Functional Conductor Type: Armored cable, BX
7. Not Present Aluminum Wiring: Not present
8. Functional Branch Wiring: Copper
9. Not Present Fuses: N/A
10. Not Present AFCI: N/A
11. Functional GFCI: At GFCI receptacles only, Kitchen and bathrooms
12. Functional Ground: Plumbing ground only

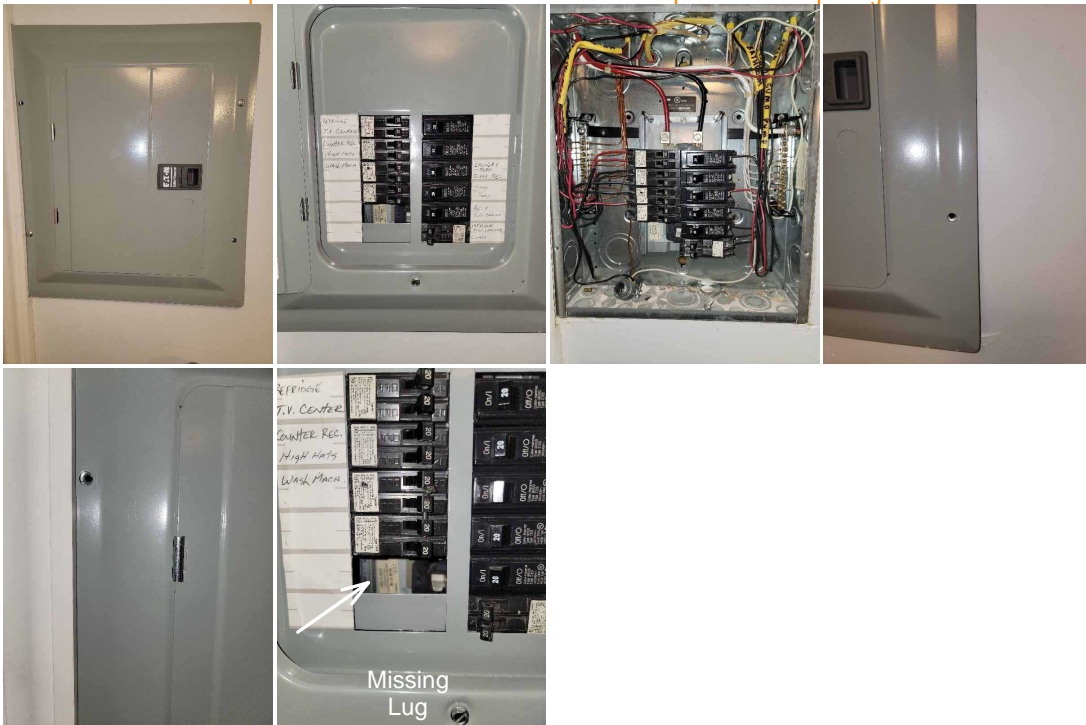
14. Maintenance Item Manufacturer: EATON - Open "knock-out" hole- insert "blank-out" cap to close off opening

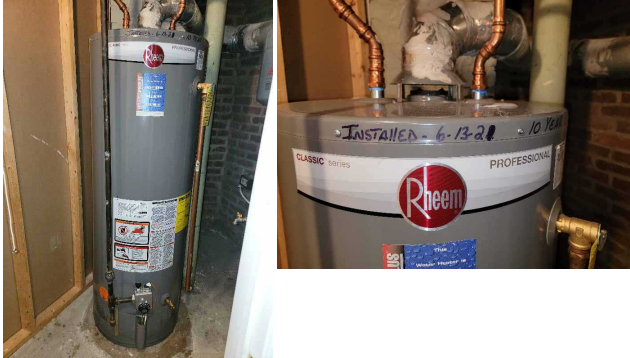
8. Functional Water Heater Operation: Functional at time of inspection

9. Type: Natural gas Capacity: 50 Gal.

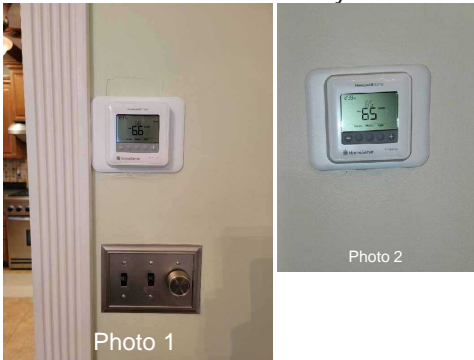
2. Functional Thermostats: Honeywell, Multi-zone, Programmable - The thermostat in photo 1 operates the heating for the first floor and basement and is located in the dining room. The thermostat in photo 2 operates the heating for the second floor and the attic and is located in the second floor hallway.

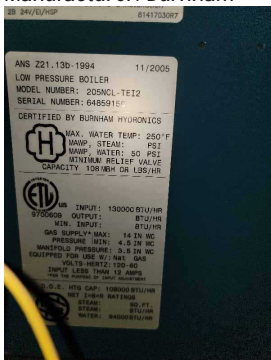
3. Manufacturer: Burnham

4. Type: Hydronic boiler system Capacity: 130,000 BTU

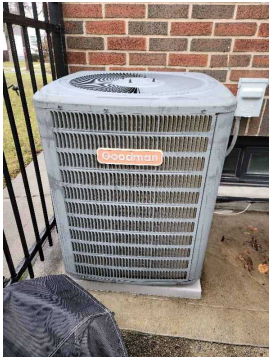
- 20. Functional Condensate Removal: PVC
- 21. Not Inspected Exterior Unit: Pad mounted - To avoid possible compressor damage the unit was not tested due to the outside temperature being below 65 degrees. When the weather is consistently above 65 degrees it is recommended that a licensed HVAC contractor be contacted for further evaluation.

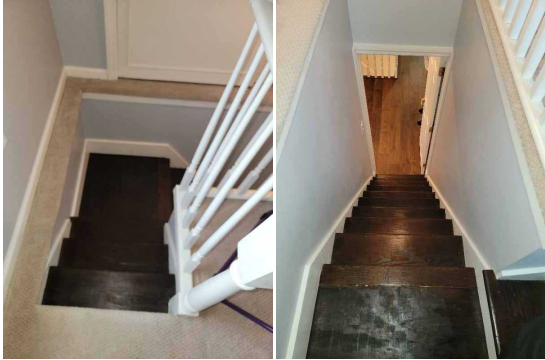
2. Maintenance Item Unable to Inspect: 80% - Due to finishes in floor, walls, and ceiling, and storage of personal items, the inspector was unable to ascertain the type of framing members and sheathing material of the roof. It was also noted that the stair that lead to attic are missing a handrail. Recommend inspection of attic area when empty and installation of handrail.

12. Main Attic Unable to Inspect: 80% - Due to finishes in floor, walls, and ceiling, and storage of personal items, the inspector was unable to ascertain the type of framing members and sheathing material of the roof. It was also noted that the stair that lead to attic are missing a handrail. Recommend inspection of attic area when empty and installation of handrail.
13. Main Attic Wiring/Lighting: 110 VAC lighting circuit and outlets - During the inspection it was noted that the closets had pig tail lights installed on uncovered electrical boxes. It's recommended that proper light fixtures be installed.

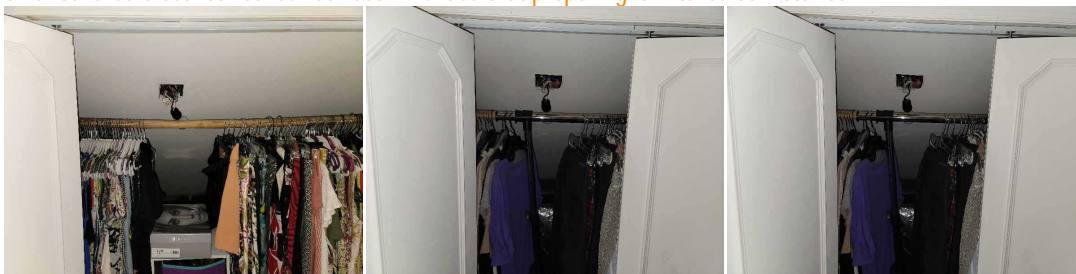
12. Maintenance Item Wiring/Lighting: 110 VAC lighting circuit and outlets - During the inspection it was noted that the closets had pig tail lights installed on uncovered electrical boxes. It's recommended that proper light fixtures be installed.

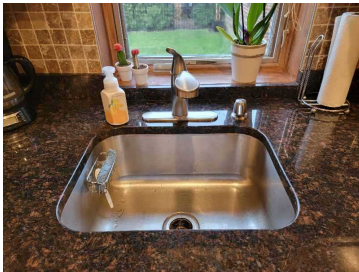
Sink: Stainless Steel

16. Maintenance Item Plumbing/Fixtures: Stainless Steel, Shut off valves are silver handled rotary style, Water lines are copper with braided metal flex lines, Drains are metal, No P-trap is installed. **The plumbing drain line is not trapped with a P-Trap. A P-Trap should be installed to prevent sewer gas from entering the house.**

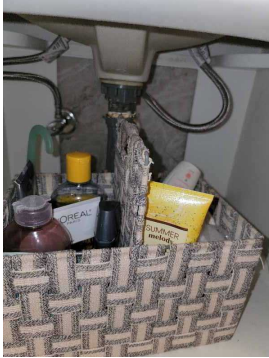
- 11. Functional Plumbing/Fixtures: Chrome single handle with metal trap. Shut off valves located under sink are silver handled rotary. Supply lines from valve to sink are flexible braided.

- 12. Maintenance Item Counter/Cabinet: Stone counter top with wood vanity - **Missing Door handle**

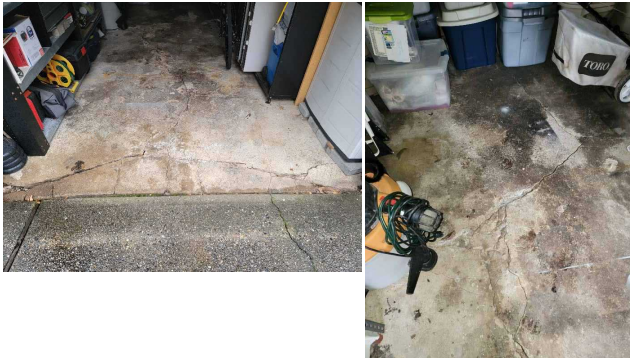
- 8. Functional Walls: Exposed framing
- 9. Maintenance Item Floor/Foundation: Poured concrete - **Minor floor cracks noted-seal cracks**

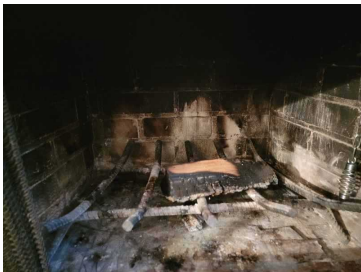
- 3. Type: Wood burning
 - 4. Not Present
 - 5. Maintenance Item
- Fireplace Insert: None
Smoke Chamber: Brick

- 6. Maintenance Item
- Flue: Brick - **The fireplace flue appears to have dirt /creosote buildup. It's recommended a licensed chimney sweep be contacted for cleaning and re-inspection.**

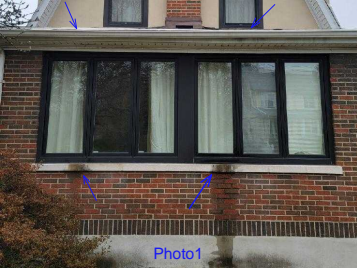
1. Gutters: Aluminum - While it appears that gutter guards were installed they were not covered with debris but, during the inspection, rainwater runoff from the roof was observed dripping from behind the gutter and dripping on to the window sill below. See photo 1. Even with gutter guards it may still be possible for debris to get under them, causing a damming effect. This can allow the water runoff to flood and overflow the gutters letting water fall/drip from in front or behind onto whatever may be below them. It's recommended the gutter guards be removed and the gutters be cleaned either by the homeowner or a licensed contractor.

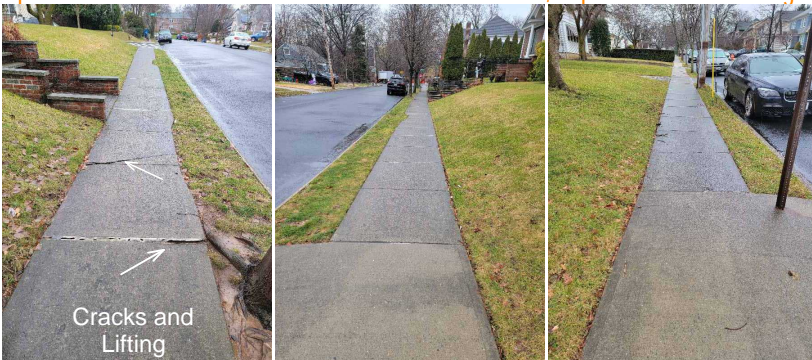
4. Sidewalks: Concrete - Cracks and minor lifting was noted in the sidewalk in front of the location. It appears to be caused by the tree root shown in photo. It's recommended that the tree root be cut back, to prevent further lifting and cracking of the slabs and that the current cracks be sealed.

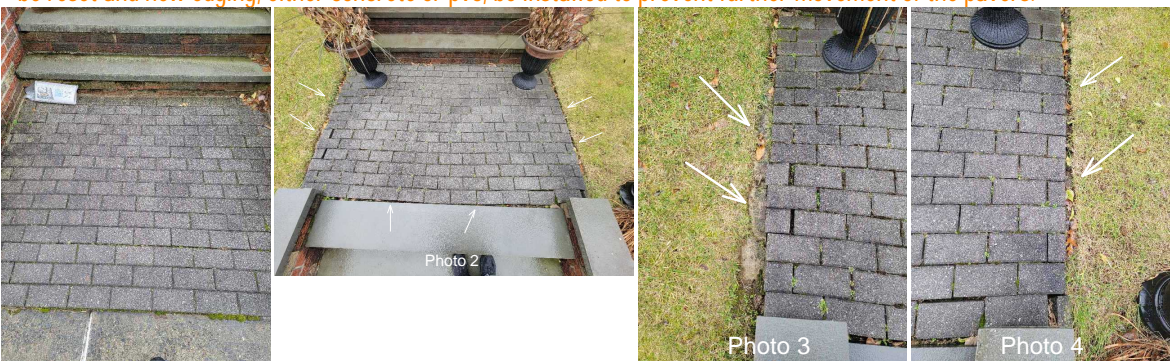
5. Front Walkway: Concrete, Brick - The brick pavers on middle landing of the front steps have become slightly uneven (photo 2). The edge pavers on both sides (photo's 3&4), are pulling away due to the sinking of the concrete edging used to lock them in place. It's recommended that these pavers be reset and new edging, either concrete or pvc, be installed to prevent further movement of the pavers.

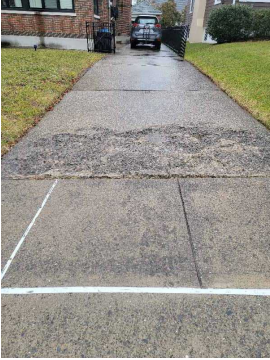
6. Driveway: Concrete - The front portion of the driveway is chipped and pitted. It's recommended that a licensed Masonry contractor be contacted for evaluation and possible repair.

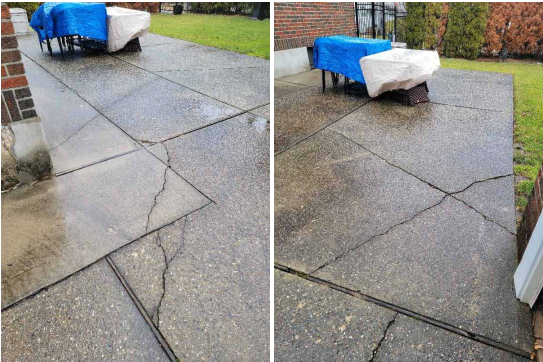
7. Patio: Concrete - The rear patio has numerous cracks in the slabs, but was still even. To prevent further cracking and the slabs becoming uneven it's recommended that the cracks be sealed. Evaluation by a licensed Masonry contractor is recommended.

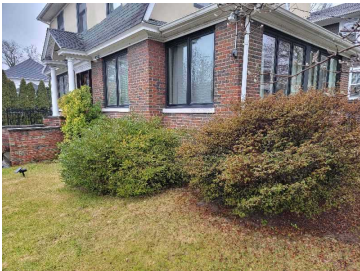
8. Vegetation: Trees, Shrubs - Overgrown shrubs were in contact with the exterior structure of the home. Vegetation too close to the structure can potentially cause harm through decay by increasing moisture retention from reduced light and airflow. Damage can be caused to screens and siding from branches abrading surfaces and leaves providing a path for moisture and insects into the home. Shrubs and bushes should be maintained at least 18 inches from the structure.

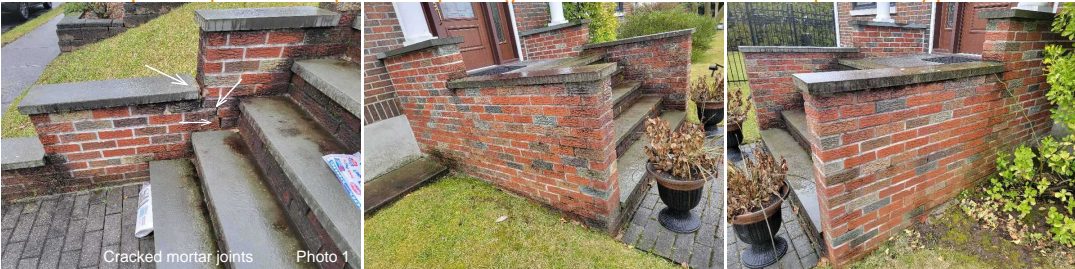
9. Retaining Walls: Brick - A minor downward sloping of the lower left side wall of the front steps has caused a few mortar joints to crack in what's called a step crack pattern. See photo 1. Repointing of the area is recommended to prevent any possible, further cracking.

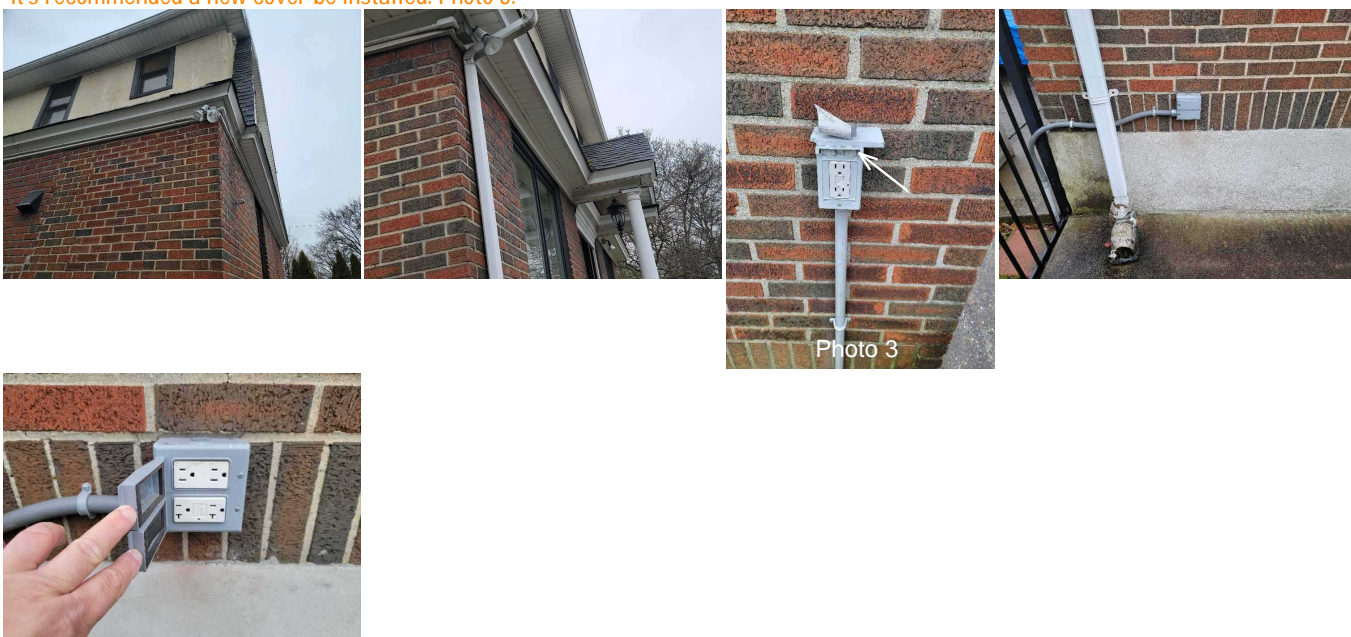
10. Exterior Electric Outlets: GFCI with weather resistant cover - The GFCI located at the exterior, side, garage wall has a broken weather resistant cover. It's recommended a new cover be installed. Photo 3.

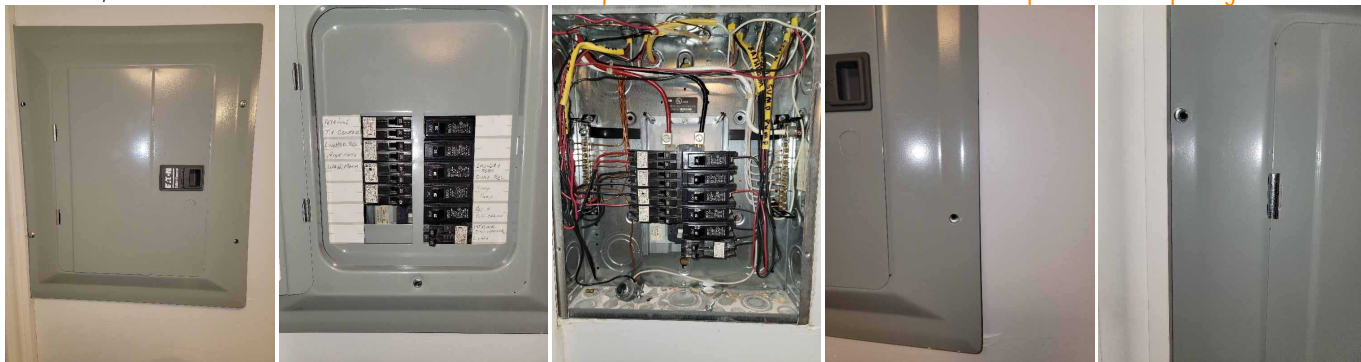
11. Basement, Sub Panel Electric Panel Manufacturer: EATON - Open "knock-out" hole- insert "blank-out" cap to close off opening

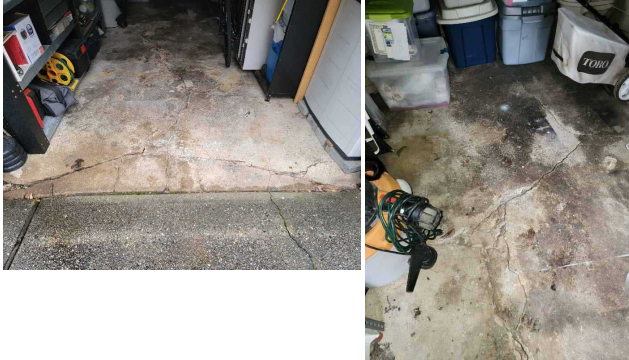
28. Detached, Rear Garage Floor/Foundation: Poured concrete - **Minor floor cracks noted-seal cracks**

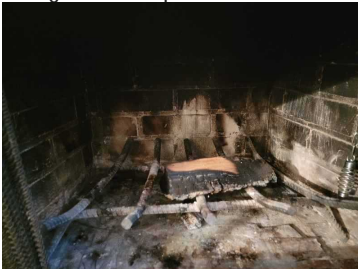
29. Living Room Fireplace Smoke Chamber: Brick

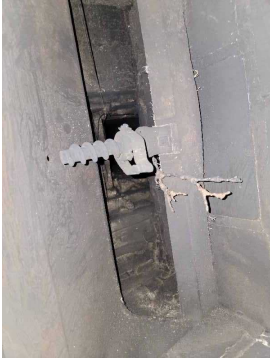
30. Living Room Fireplace Flue: Brick - The fireplace flue appears to have dirt /creosote buildup. It's recommended a licensed chimney sweep be contacted for cleaning and re-inspection.

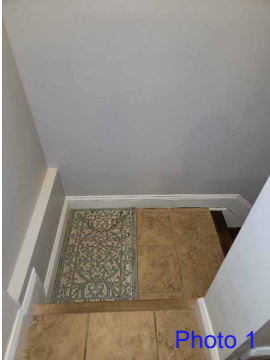
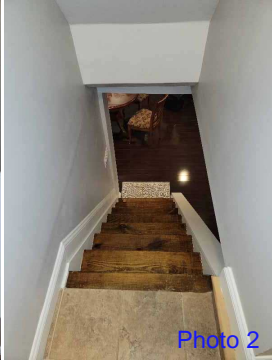
2. Defective Stairs/Railings: Wood stairs - It was noted that one side of the basement stairs are open and that there is no handrail installed. A person can possibly fall through this area and may possibly be injured. It's recommended that a handrail be installed. See photo 3.

1. Main Basement Stairs/Railings: Wood stairs - It was noted that one side of the basement stairs are open and that there is no handrail installed. A person can possibly fall through this area and may possibly be injured. It's recommended that a handrail be installed. See photo 3.
